Failure of Superstructures after the “February 03, 2002 Sultandagi-Cay, Earthquake”

M.Y. Kaltakci, M.H. Arslan, H.H. Korkmaz and M. Kamanli
Department of Civil Engineering, Faculty of Engineering and Architecture,
Selcuk University, Konya, Turkey

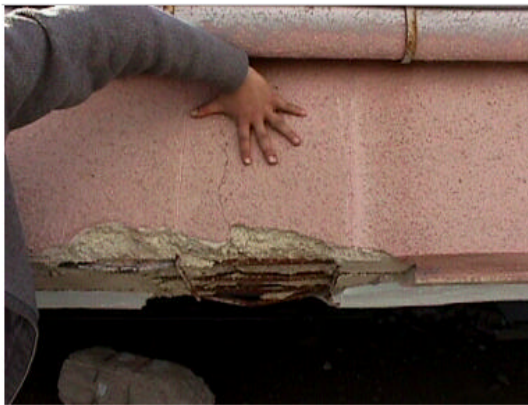
Fig. 4b: Insufficient material and detail in a column

Figure 4b was taken from damaged beams that had no adequate transverse ties in any section of it. Figure 5 shows damages that were occurred from insufficient material and detail on a beam-column connection.

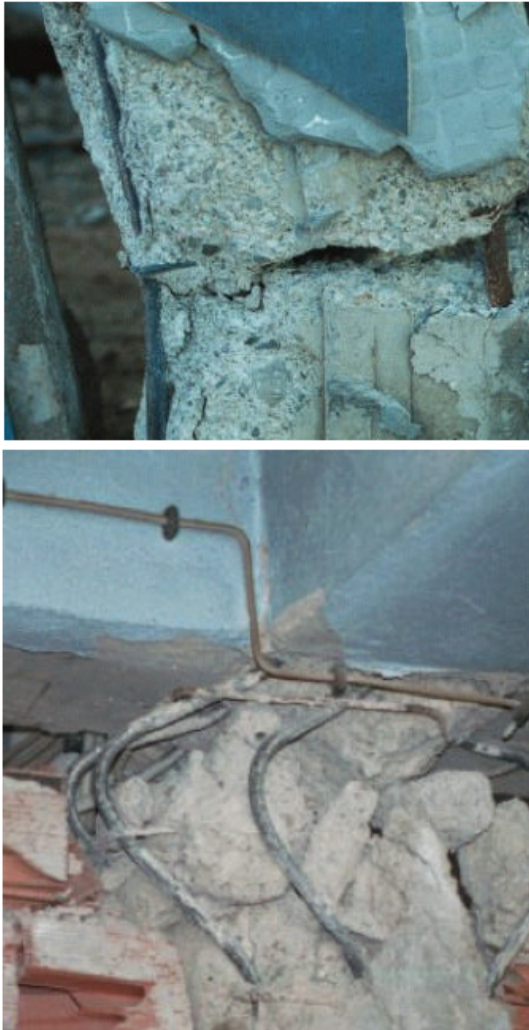
In damaged columns and beams, the transverse ties are smooth rebars of 6-8 mm diameter with 90-degree hooks. The spacing of transverse ties is between 300 mm

Fig. 6: Insufficient material and detail in a column

and 400 mm and there is no confined region. Further, anchorage length, l_b , is less than code's requirement's. In addition, the poor concrete affected anchorage length negatively. The majority of moment-frame component failures was in columns and was due to the use of nonductile details and unconfined lap splices (Fig. 4a and b). Also in columns clear cover was inadequate, plain reinforcing bars were used and hoop angles were 90° instead of 135° . Figure 6 (Erdik *et al.*, 2002) shows insufficient material and detail in a column. According to TEC-98, the longitudinal rebar ratio (ρ_l) ranges between 1% and %4. The authors have observed that in seismic regions column's ρ_l is ranges less than 1%. 12-16 mm diameter smooth rebar are generally used but with respect to TEC-98 minimum bar diameter must be 14 mm. For instance, Fig. 7 shows that the damaged column's ρ_l is less than 1% and the spacing of transverse ties is between 300 mm.

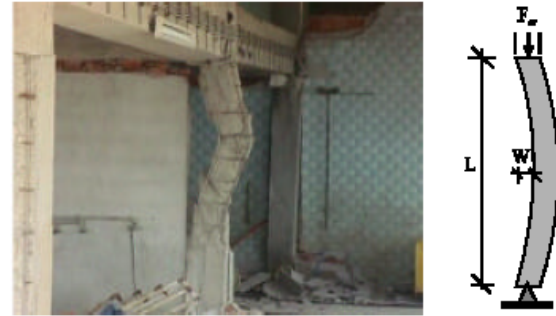
Fig. 7: Buckling column damage in industrial facility of Cay

Some columns have met the buckling damages in this area. During the earthquake, this kind of failure type has been seen rarely. But in this sample, critical load acting on weak column is exceed the limit value of buckling. The limit (critical) buckling load level (Euler's Formula) is given in Eq. 1. In this formula, it is obvious that the critical buckling load decreases with the square of the column length. Figure 7 shows buckling RC column damage in industrial facility of Cay.

From the Eq. 2, it can be easily seen that, the increase of w causes increasing of second degree moment. In the structural calculation, columns are assumed having small mid-deflection (w), but the column that is represented in Fig. 7 have 35-40 cm deformation and this deformation caused the columns collapse.

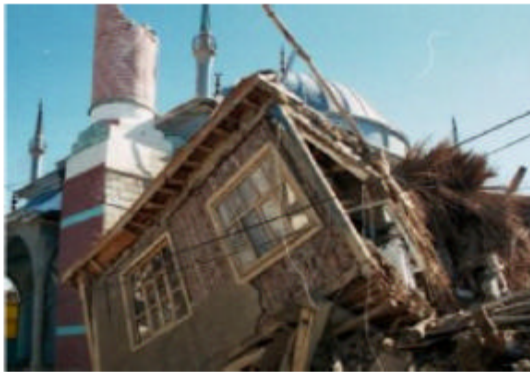
Fig. 9: Highly damaged non-engineered structure

condition. The minarets of some mosques failed due to low quality of mortar (Fig. 9). In this region, the number of stories is generally 2 and the building stock consists of traditional building type that are made with rural and traditional materials. The neighboring structures are adjacent at one side. The materials used are sun dried earthen bricks and wood. The damage was concentrated on non-engineered structures which were one story and earthen adobe or two story wooden structured and infilled with mud. The roof system was, 7 cm clay laid on a 6-8 cm bamboo and wooden beams. After the decay of wooden roof beams, they could not withstand the load of the heavy roof. The walls of damaged buildings were also decayed due to ground water and atmospheric conditions. Also minarets of mosques failed. In this town, there was almost non-engineered structure.

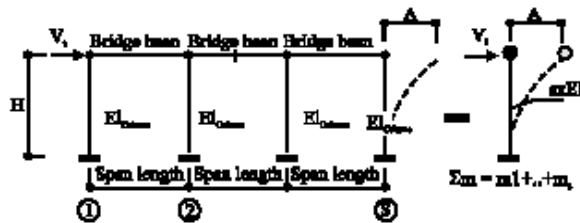
Fig. 12: Displacement of bridge columns under lateral loading

Figure 12 represents the finite element (bar) model of bridge under lateral loading. The long span pretensioned beams are assumed having hinged column connection. The bridge columns have fixed support and this column behavior is similar to cantilever beam. In the Eq. 4, the method of lateral displacement calculation is given.

affected region, the bridge column height is 5-7 m averagely. Almost all bridge beams have separated from each other after the earthquake. But there was no falling down beam.
