## A Study on Visual Assessment of Sylhet-Sunamganj Highway Using an Expert System

**Abstract:** The primary function of pavement is to distribute the concentrated loads so that supporting capacity of the sub-grade soil is not exceeded. Due to continuous application of impact loading, pavement surface often subjected to various types of distresses. The study was conducted on a portion (madina market to tucker bazar) of Sylhet-Sunamganj road that acts as a very important link between two adjacent towns. Pavement Condition Ratings (PCR) of the pavement was obtained on the basis of severity and extent of different types of distresses such as alligator cracks, longitudinal cracks, potholes, rutting, raveling, patching, etc. The PCR values of different segments of madina market to tucker bazar were evaluated in this study most of which fall within the category of very poor to poor conditions. Such condition of PCR immediately recommends proper treatment of the pavement for usage convenience.

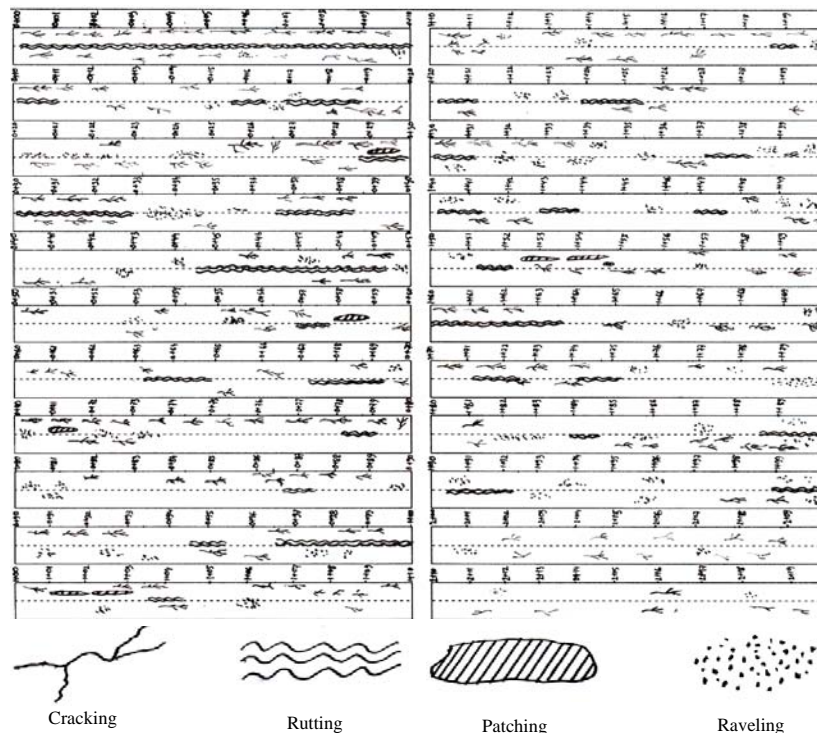
Fig. 1: Plotting of various types of distresses along road sections

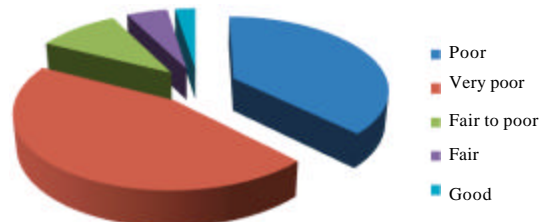
**Pavement condition determination:** A typical representation of the road network's present situation is given by Fig. 4.

Fig. 4: Pavement condition rating of road network madina market to tuker bazar section of Sylhet-Sunamganj highway
