Soil Erosion Problems in Upper Ala Watershed, Southwestern Nigeria

Olatunji Abiodun Johnson

Abstract: Soil erosion problems at the headwater of Ala watershed which drains a rural community north of akure, southwestern Nigeria, was investigated. The watershed was listed as one of the focal points of UNDP's programme on Sustainable Agriculture, Environment and Rural Development in Nigeria. Baseline survey of the watershed reveals that the following environmental factors contributed to the observed erosion problems: Long, gentle to relatively steep slopes; low infiltration capacity; heavy and prolonged rainfall; highly erodible soils; inadequate and blocked storm drains and unplanned land use types. Indicators of soil erosion identified in the area also include: Detrital materials and coarse sand deposits; bare unvegetated surfaces devoid of top soil; stone capping of soil pedestals; exposed building foundations. These factors and indicators have combined to produce rapidly incising gully systems along some long slopes. At some midslopes and southern basal positions currently being opened-up for various developments, small and few storm drains have promoted sheet erosion and street

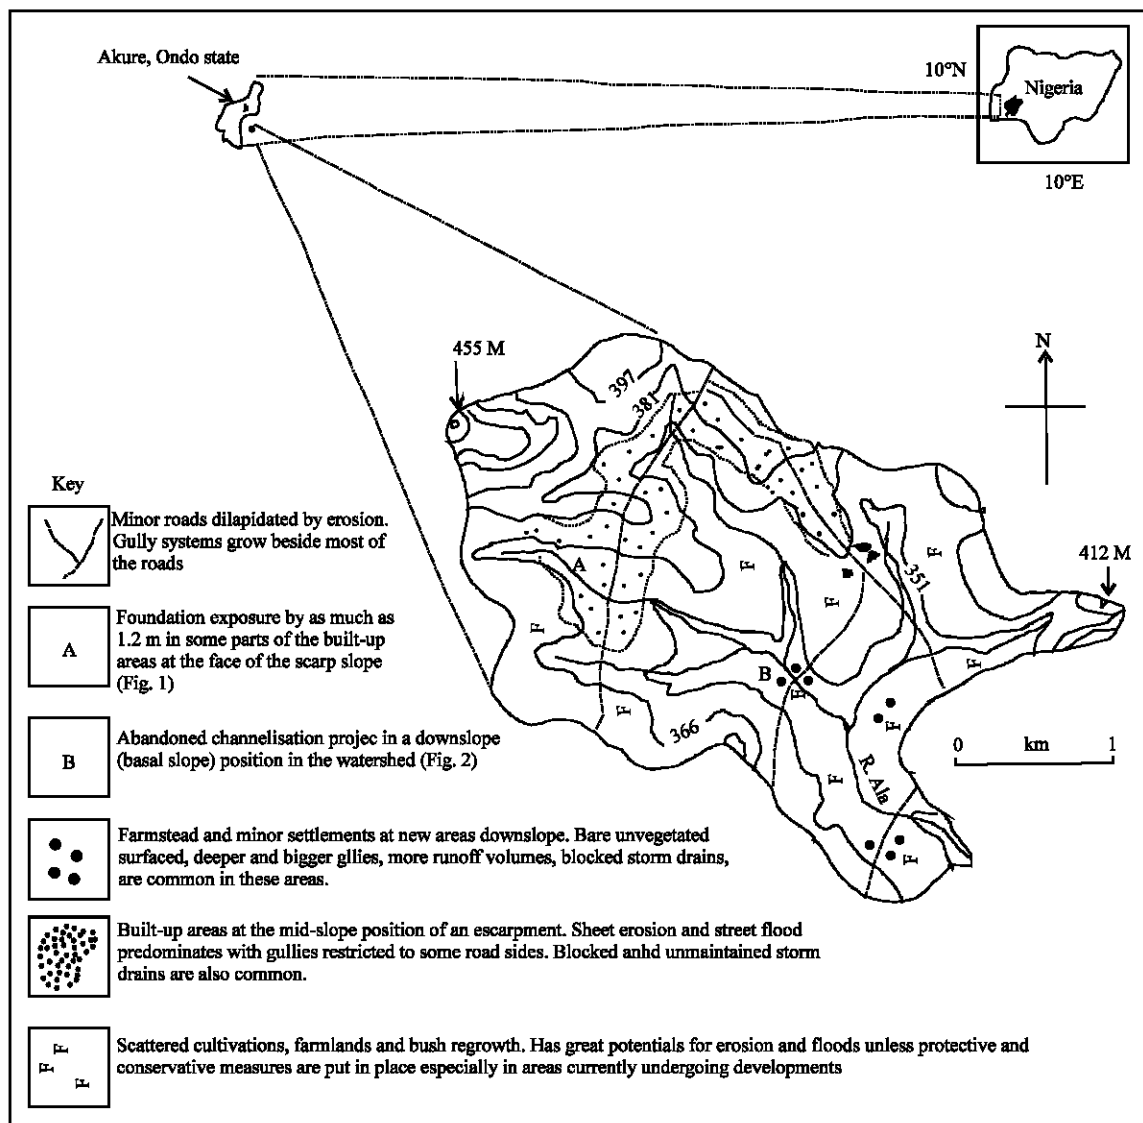
Fig. 1: The upper Ala watershed

Slope lengths within the watershed vary between 30 to 315 m. Slope gradient also vary from 5-28 with a mean of 19. Generally, the area is dissected by erosion with incisions varying in size from very small rills with channels that are hardly discernible to gigantic gullies characterized with near-vertical sides and measuring more than 1.7 to 5 m deep in some locations (Fig. 1 and 2).

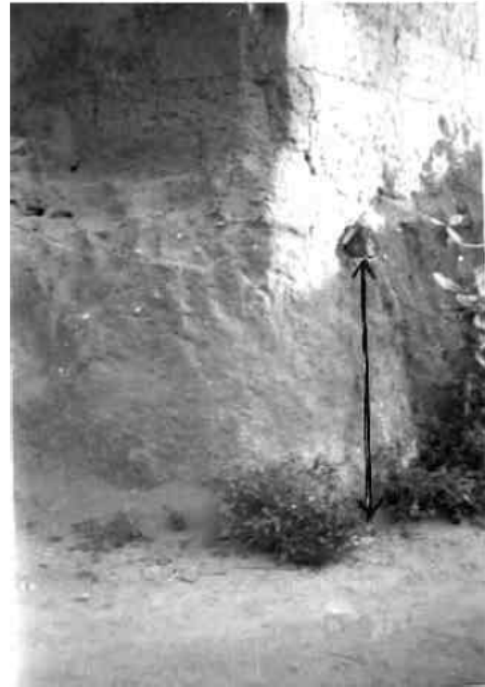
Discrete, snap shot measurements of exposures of tree root and building foundations are good indicators of soil loss and ground surface lowering by sheet erosion. This is more prevalent within the built-up areas of the community where exposed building foundations averaged 20 cm and are only delicately supported by outcropping duricrust concretions (Fig. 2). In some locations root exposures also vary from 20-30 cm.

Fig. 2: Foundation of a mudhouse exposed by 1.2 m (shown with arrow) by sheet erosion and street floods over duricrust concretions within the built-up areas (site A in Fig. 1)

approach to make them effective. Drainage systems that have been blocked must be reactivated and maintained to discourage sheet erosion and street floods. More drainage and channelisation systems must be put in place to ensure undisturbed routing of runoff water during storm-runoff events (Olatunji, 1998a).

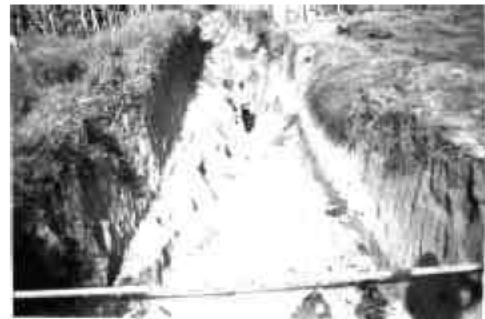
Fig. 3: An abandoned chmelisation project overtaken by gullies in a downslope position currently undergoing various developments (site B in Fig. 1). An exposed pipe and the author were shown at the background
