## A Technique for Identifying and Characterizing the Microcracks Produced in Machined Surfaces

<sup>1</sup>M. Gaceb and <sup>2</sup>D. Gillibrand

**Key words:** Microcracks, surface integrity, machined surface, transmission electron microscopy

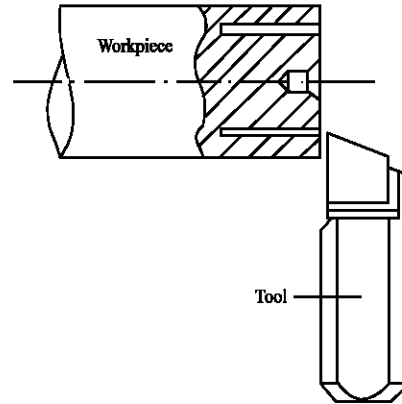
Fig. 1: Orthogonal machining operation

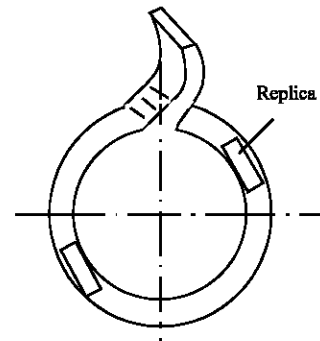
Fig. 2: Machined surface with attached chip

**Replication of the machined surface:** Prior to replication each machined surface is carefully degreased and washed in acetone before ultrasonic cleaning in trichloroethylene. The surface is then replicated at two random positions around the annulus (Fig. 2). A two stage plastic-carbon replication procedure with gold/palladium (60/40) shadowing was adopted. The replication consists of

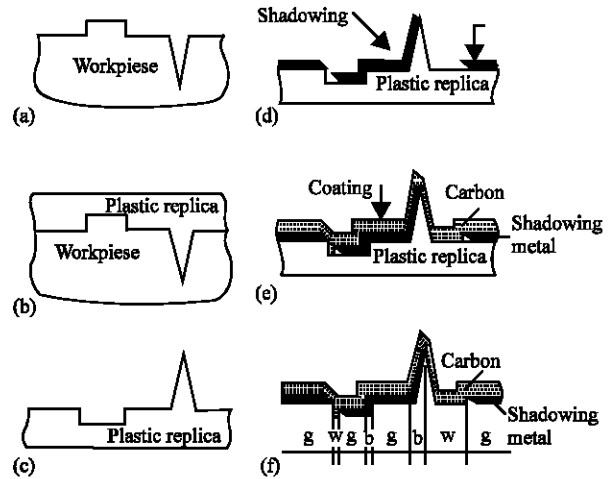
Fig. 4: Surface replication procedures (a) profile to be replicated (b) surface replication (c) plastic replica (d) Au/Pd shadowing (e) Carbon coating (f) Replica with dissolved plastic showing the contrast shade sequence

The shadowed and coated replica is finally cut into small squares whose size allows them to be mounted on 3 mm diameter copper support grids with the carbon coating facing downwards and immersed in acetone to dissolve the plastic substrate leaving the two stage replica of the machined surface. The complete procedure of the TEM specimen preparation is summarized in Fig. 4.

Figure 4 (f) shows the contrast shade sequences for a given surface. The sequence for a microcrack is Grey-Black-White-Grey (GBWG) as shown in Fig. 5. A micrograph showing the contrast shade sequence of a microcrack in the shadowing direction is shown in Fig. 6. Given a 45 degree shadowing angle to the surface, the measurement of the width of the white shade in the shadowing direction constitutes a direct measurement of the microcrack depth. The arrow indicates the shadowing direction which is also at  $45^\circ$  to the cutting direction.

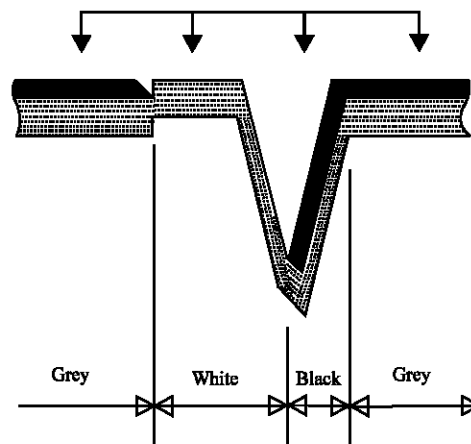
Fig. 5: Contrast shade sequence of a microcrack

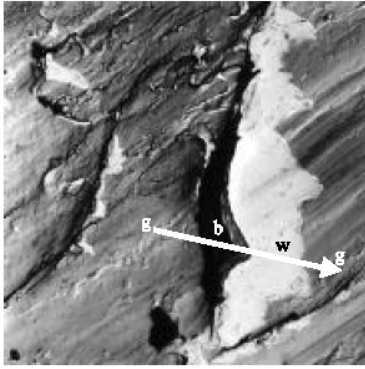
Fig. 6: Micrograph showing the microcrack

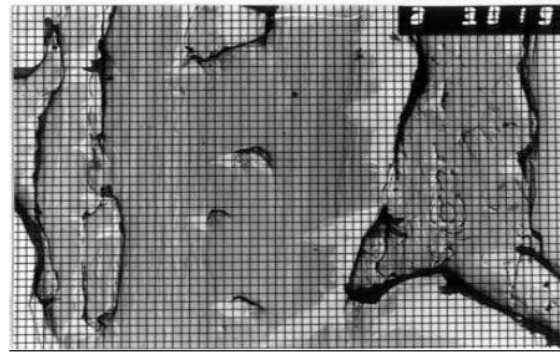
Fig. 7: Grid pattern for MAR measurement

To measure the microcrack area, a grid pattern 84 by 57 mm is superimposed upon the micrograph of the surface under consideration as shown in Fig. 7. The microcrack area is obtained by counting the squares of the grid pattern which fall within the white shade of the contrast pattern corresponding to microcracks. The counting is done manually although it is suggested to do this automatically directly in the transmission electron microscope or using some computer image processing means in future study.

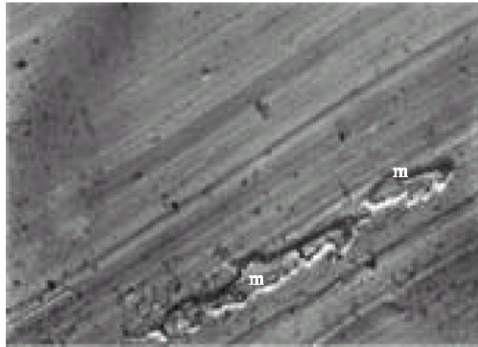
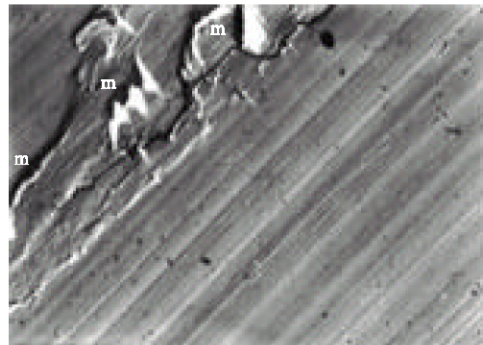
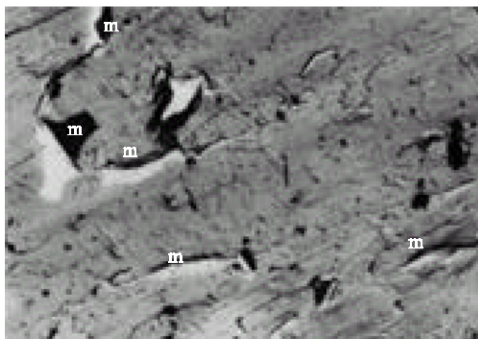
Fig. 8: Micrograph of the machined surface of (a) The stainless steel (b) The medium carbon steel (c) The free cutting steel

The results show that the extent of microcracking is greatest for the free machining steel and least for the stainless steel. The number of microcracks however is more or less the same in this case. This seems to suggest that the size of the microcracks decreases from the leaded resulphurized free cutting steel (A) to the stainless steel (C).

Visual confirmation of these results is provided by typical micrographs of the surfaces obtained for the three materials as shown in Fig. 8a-c. The microcracks are designated by the letter m.
