Investigate the Geological Conditions of Eyvashan Reservoir Dam Site and the Reasons for Choosing the Best Type of Dam Building

Abstract: The under construction Eyvashan dam site in Lorestan Province is located in 57 km Northeast of the Khorramabad city on Hored River. The site of this dam, from geological point of view is in bedrock ranging that is composed of conglomerate rocks. Conglomerate rocks of abutments range have protrusions. Young alluvial deposits covered the bedrock surface in valley floor. The aim of this study is to investigate the geological parameters of Eyvashan dam site and the reasons for choosing the best type of dam building and also the stability of the structure in order of size motechinque. The study method has done based on research, data collection in library studies, field and laboratory ways. After identification and evaluation of geological and geotechnical of dam structure, litho logy and tectonic characteristics were studied by using satellite data. In choosing the type of dam issues and several factors such as the shape of the valley, engineering geological conditions and results of exploration drilling and geotechnical studies, site conditions, th

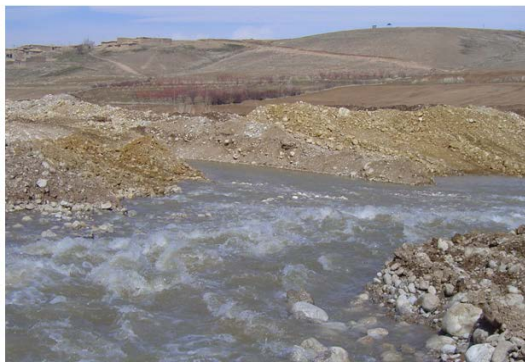
Fig. 3: Pleistocene conglomerate in the place of Eyvashan dam site on Herod river in the Southern village of Eyvashan

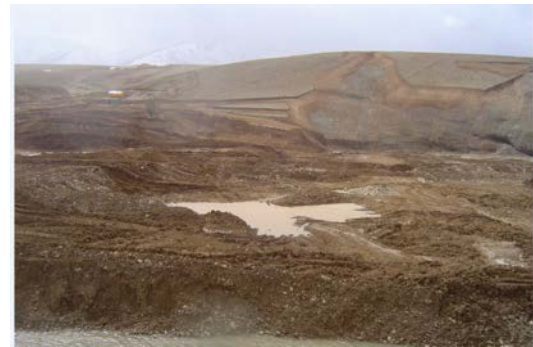
Fig. 4: View of the under construction dam site conglomerate of Eyvashan

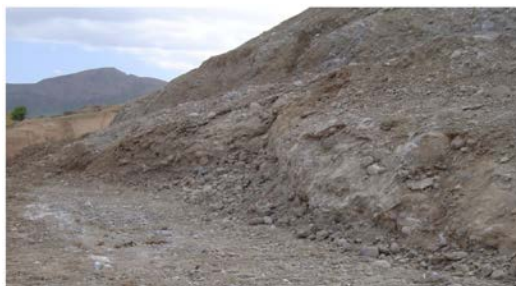
Fig. 6: Close view of polio pleistocene conglomerate protrusions in the south of the case study area in the picture the texture of the conglomerate and litchis fragments are visible

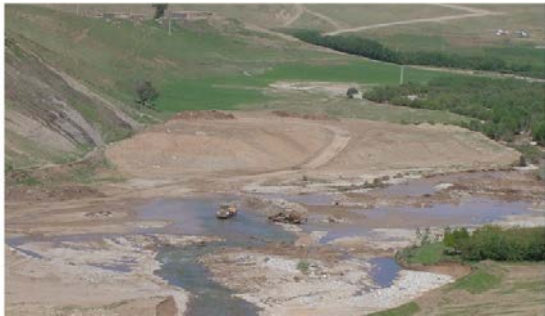
Fig. 12: View of the sediments of the surface of Herod River

These deposits are the creature of a lacustrine environment because fossils and ear of fish can be seen in them; these fine-grained sediments as a source of credit are studied. The way of Eyvashan river is covered by sediments of sand and boulder up to a diameter of about 1 m (Fig. 12). The maximum thickness of the sediments in the area around the dam and in the lake is about 6 m. The deposits are predominantly made of limestone but parts of igneous, metamorphic consists of Andesite, basalt, slate can be seen in them. The sediments are the source and aggregate gravel shell of Eyvashan dam.
