## GFRP Retrofitting of Reinforced Concrete Beam Exposed to Elevated Temperature

**Abstract:** This study presents the results of an experimental study aimed at investigating the flexural behavior of Reinforced Concrete (RC) beam retrofitted with Glass Fibre Reinforced Polymer (GFRP) by using Near Surface Mounted Method (NSM) when exposed to an elevated temperature. A total of 7 numbers of 150×150×750 mm RC beams were tested under a three-point bending test. The experiments results show that the flexural strength of all the control specimens decreased with increasing temperature. However, the GFRP retrofitted specimens improves the flexural strength of the beam specimens by 50, 44 and 43% for specimens burned at 200, 600 and 800°C, respectively as compared to the control specimen. Therefore, NSM retrofitting method with GFRP is proven to be effective to maintain a beam structure that was exposed to the elevated temperature.

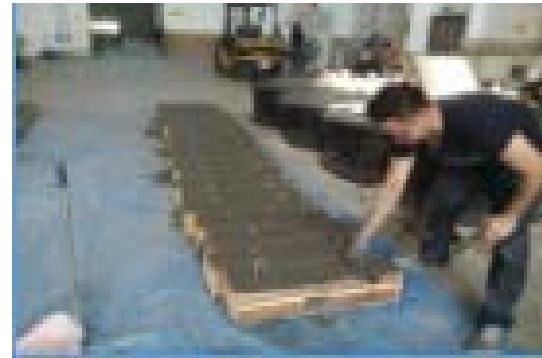
Fig. 1: Concrete casting of RC beam

**Concrete casting and burning process:** Concrete casting took place after all the materials and formworks were prepared. Figure 1 shows the concrete casting work of the RC beams. The compressive strength of the concrete was determined at the age of 7, 14 and 28 days. All specimens are left in room temperature and covered with wet gunny sacks for 28 days for curing purpose. After 28 days, 6 numbers of beams specimens were burned according to the designated temperature for one hour. High cautions need to be observed throughout the burning process of the beam specimens to ensure safety.

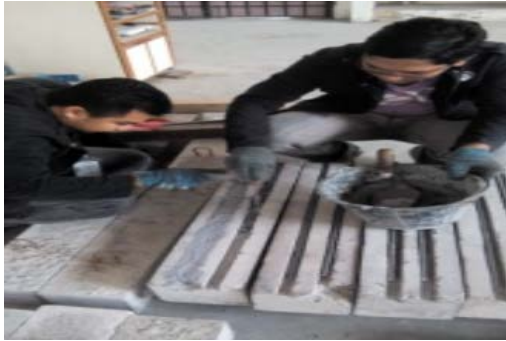
Fig. 3: Beam specimens with complete grooves ready for GFRP installation

Once the groove details were finalized, the position was marked, followed by the hacking work. The grooves were then dusted to ensure that the grooves were clean. After the grooves were ready, GFRP reinforcement bars were then installed. Figure 3 shows beam specimens with complete grooves ready for GFRP installation. Half of the groove was filled with epoxy and GFRP was placed on top

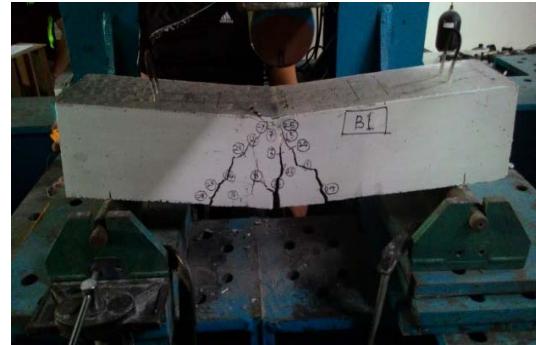
Fig. 7: Mode of failure for control sample

**Crack observation:** There are several modes of failures occur in this study which is the bending and shear failure. The behaviors of the beams were different for control specimens and retrofitted specimens. It was observed that the control specimens A1, B1, C1 and D1 failed in bending while retrofitted sample B2, C2 and D2 failed in shear. The additions of GFRP increased the flexural strength thus causing the beam to fail in shear. The failure occurred by the crushing of concrete when GFRP was not present thus leading to bending failure for control specimens. On the other hand, the presence of the GFRP bar helped in transferring the load to GFRP thus producing shear failure (Fig. 7 and 8).

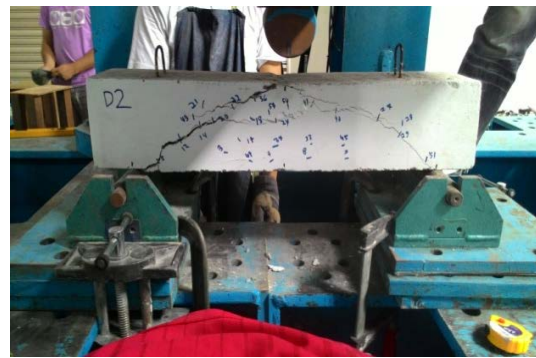
Fig. 8: Mode of failure for retrofitted sample
