Compression Zone Rehabilitation of Damaged RC Beams Using Polyester Glue Line

Nabeel Hasan Ali Al-Salim, Rafea Flaih Hassan and Muna H. Jaber
Department of Civil Engineering, College of Engineering, University of Babylon, Hillah, Iraq

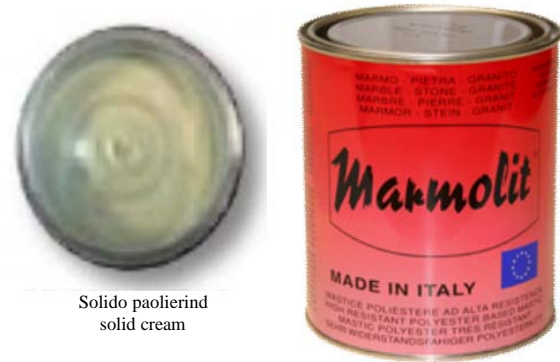
Polyester glue line: The properties of polyester glue line is straw solid cream polyester resin processed with suspended minerals as shown in Fig. 2. It is especially recommended for gluing, repairing or making stuccowork. The characteristics are strong binding power, rapid hardening, easy application, very good polish and homogeneous color. The physical properties obtained from manufacturing data (<http://www.b-chem.net/>) are listed in Table 3.

Fig. 2: Polyester glue line

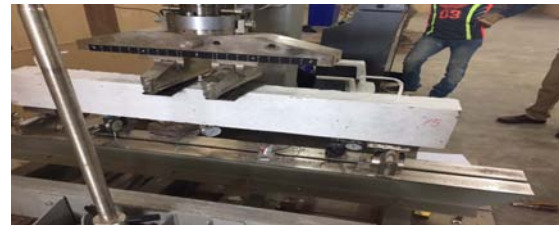
Fig. 3: Testing machine of RC beams

supports and at midspan using three dial gauges so that the net displacement can be obtained by deducted midspan displacement from the average of displacements close to supports as shown in Fig. 3.

Instrumentation and test setup: After curing and rehabilitation mechanical testing of the beams was carried out (ASTM C192/C192M-02) (Anonymous, 2001, 2002a-c). Vertical deflections were measured near the

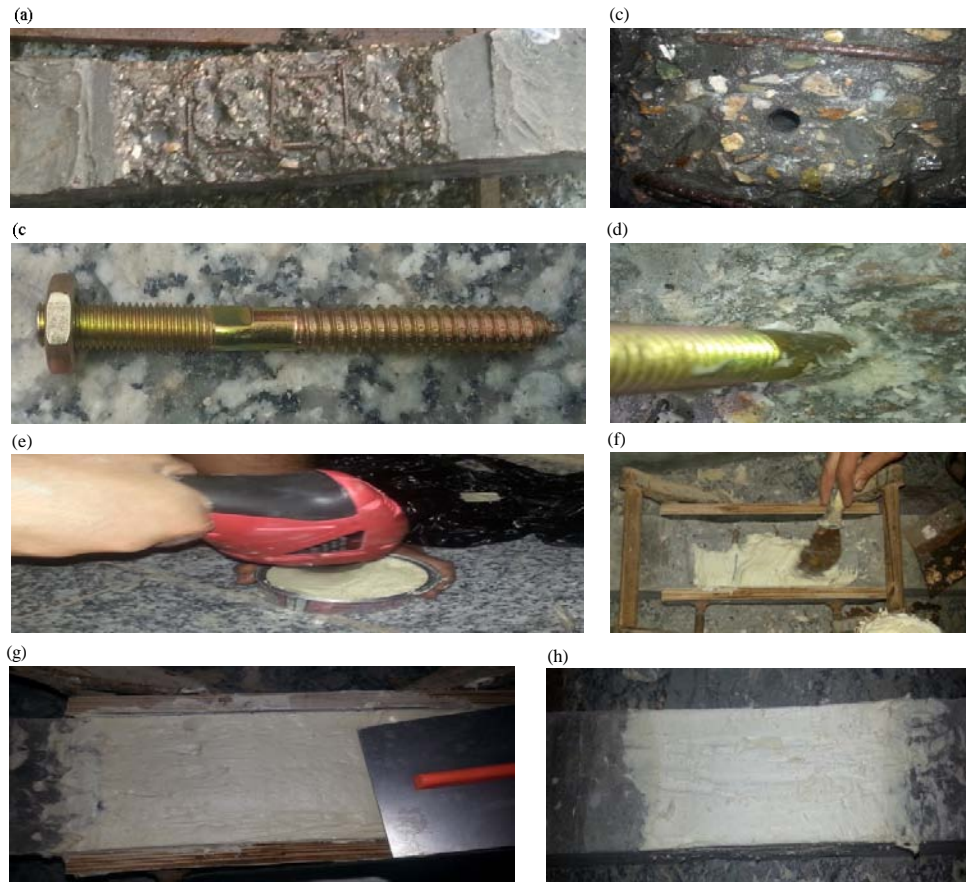
Strengthening of damaged specimen: After crashed intended region of beams (3 cm from depth) of compression zone with different length (10, 20 and 30% of tested length of specimen at center), result crushed surface was cleaned by potable water and was left it until dry as shown in Fig. 4a. The $\phi 10$ mm holes for shear connectors was drilled along the center line of beam with depth of 5 cm at 7 cm center to center spacing. The shear connectors were fixed to the holes using the same polyester glue line shown in Fig. 4d. The polyester resins were prepared following the manufacturer's directions by mixing two components (resin and hardener components). The hardener was add with 2% of the polyester glue line and mixed using low speed drill. The mixed resin was applied on damaged zone using a trowel as shown in Fig. 4g.

Fig. 4: Repairing with polyester glue line: a) Clean the damaged zone; b) Hole of shear connector; c) Shear connector; d) Fixed shear connector; e) Mixing polyester glue line; f) Pervading polyester glue line; g) Adjustment polyester glue line and h) Repaired damaged zone

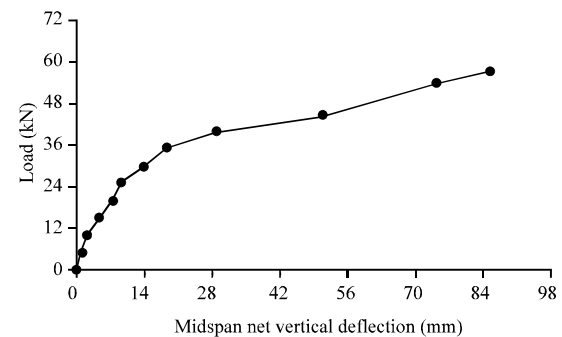
Fig. 12: Load-midspan net vertical deflection of specimen B30

afford slight enhance in the ultimate load and ductility from that obtained of beams without shear connectors while the first crack load was equal as shown in Fig. 9-14.

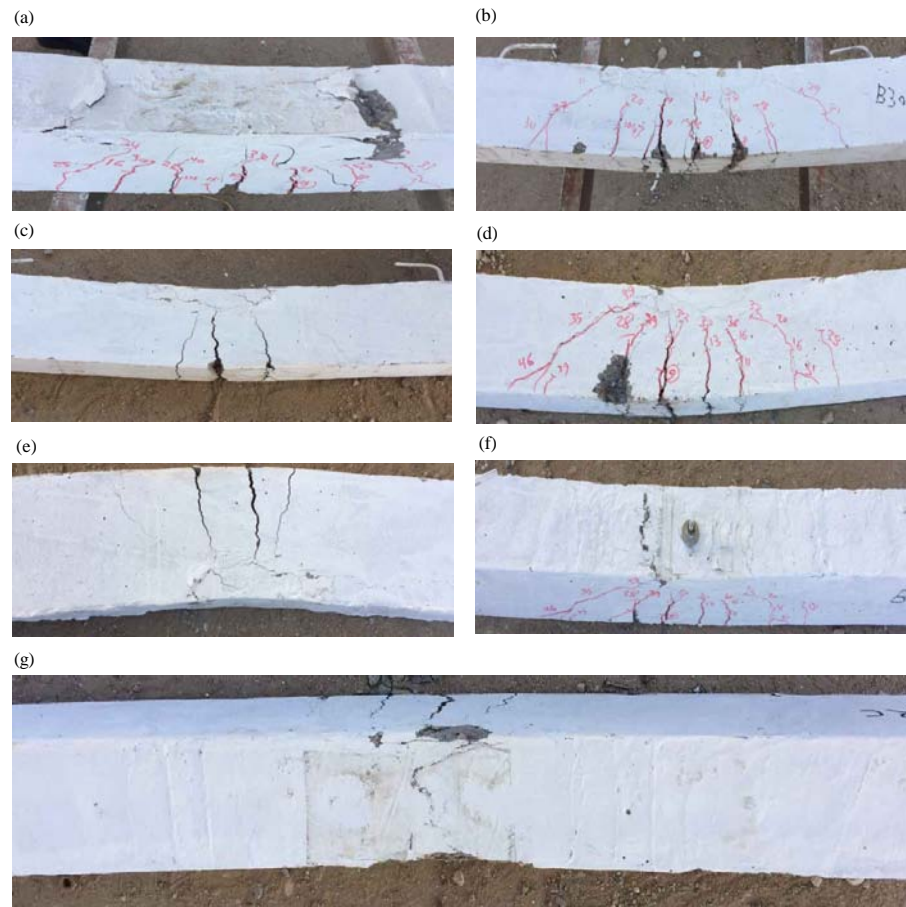
Fig. 14: Beams after failure: a) R30; b) B30; c) R20; d) B20; e) R10; f) B10 and g) R

The failure of all rehabilitated beams occur when the concrete was crushed at the end of polyester glue line as shown. Also, polyester glue line still bonded with concrete after failure for all specimens. Significant enhancing of beams behavior when the polyester glue line was used as compared with other strengthening materials, especially in cost.
