Ameliorating Water Supply Problems in University of Nigeria, Nsukka

Abstract: Supply of abundant safe water has great influence on the health, economic productivity and quality of life of the people. Meeting this need is one of the major challenges facing both the rural and urban communities of Nigeria today. Therefore, improving water supply should be a major focus by the government, NGO's and other concerned bodies. There is disparity between the present daily water supply in the University of Nigeria, Nsukka by the university water works unit and the daily water requirements for the university residents. The estimated daily water requirement is 1,709,879 L/day and the estimated average quantity produced daily is 1,620,000 L/day but experiences 20-30% loss. Average of about 1,280,000 L/day reaches the consumers. Therefore, percentage of requirements satisfied is 74.86% implying that the university water works unit still needs about 25.14% of its current level of water supply to satisfy the total water requirement. The analysis of the water from the university water source shows that the quality indices of the sample were appreciably acceptable and the microbial analysis is withi

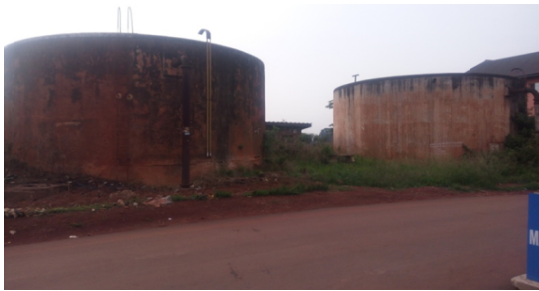
Fig. 1: Abandoned Odenigwe UNN twin reservoir. It has a combined capacity of 1376 m³. (Odenigwe, Nsukka)

Storage: There are 3 main reservoirs within the university community, the shaft reservoir, one pipe system and two pipe system. One is located at Ugwu Edega, one behind works services department and the Odenigwe twin. Due to their elevations water is distributed by gravity flow. The Ugwu Edega reservoir is used to serve all the hostels and some streets within the campus. The works department reservoir is fed from Franco borehole and also serves the Franco hostels and environs. The Odenigwe twin reservoir has been out of service for long now. It used to serve the upland senior housing. Also low level reservoirs have been established at some strategic points in the university to act as standby in times of shortage and firefighting purposes (Hazen-Williams, 2009) (Table 3).

- Odenigwe twin = 1,360,000 L
- Edega = 680,000 L
- Works department reservoir = 909,000 L
- Total = 2,949,000 L

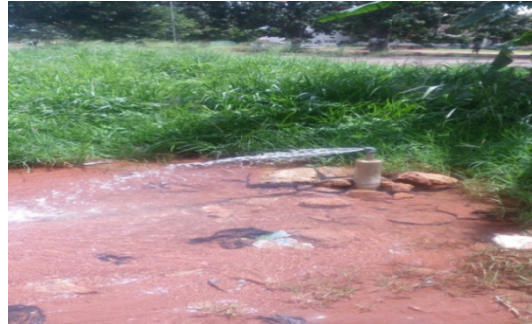
Fig. 4: SCC borehole 2 UNN

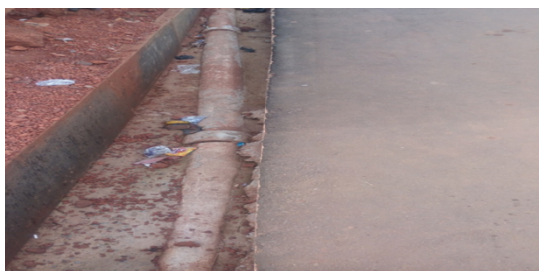
Fig. 2: Drainage line of the newly constructed Sam Onyishi Road. The drainage line was constructed on the main lines to the Odenigwe Reservoir, this could cause pipe bursting during the excavation of the drainage line

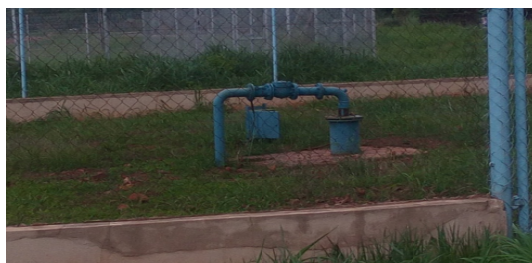
Fig. 5: SCC borehole 3 UNN

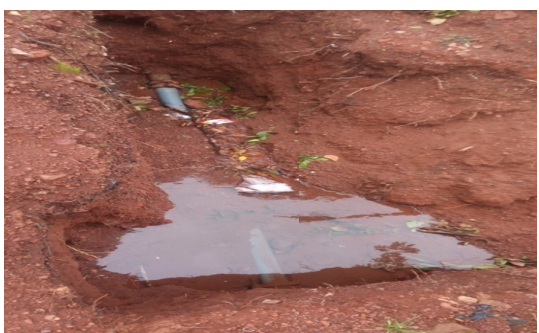
Fig. 3: Leaking pipe at one of the minor lines along Ikejiani Avenue, UNN

Therefore, the capacity of the existing reservoirs is adequate for the present needs. These reservoirs should serve temporarily as service reservoirs. The current pipeline network should be either given a total overhaul or partial one so that they can be properly maintained. The issue of burst pipe has become a major reoccurring problem in the University due to that most of the pipes are over aged.

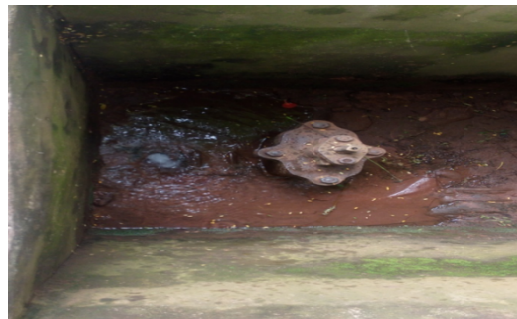
Fig. 6: Leaking control valve at Ikejiani street UNN

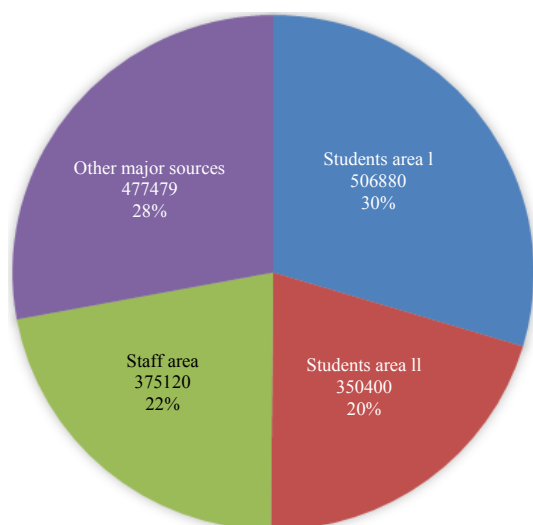
Fig. 7: Pie chart showing the estimated daily water requirements by the different areas in UNN in liters

- Students residential area I (girls' hostels) estimated daily water requirements = 506,880 L/day
- Students residential area II (PG and boys' hostels) estimated daily water requirements = 350,400 L/day
- Staff residential areas in the campus estimated daily water requirements = 375,120 L/day
- Estimated daily water requirements by other major sources = 477,479 L/day
- Total = 1,709,879 L/day

Major sources include daily water requirement from: refectories, power houses consumption rate, CEC consumption rate, firefighting consumption rate, laboratories, medical center consumption rate, swimming pool consumption rate, stadium, student's recreation centers consumption rate, staff club consumption rate, banks consumption rate, etc (Fig. 7).
