Bands's Rupture Prediction of the Conveyors by Reliability Analysis

A. Belhamra, A. Yousfi and E. Hadjadj-Aoul
Département Electromécanique, Faculté des Sciences de L'Ingénieur
Laboratoire des Systèmes Electromécanique, Université Badji Mokhtar Annaba, Algeria

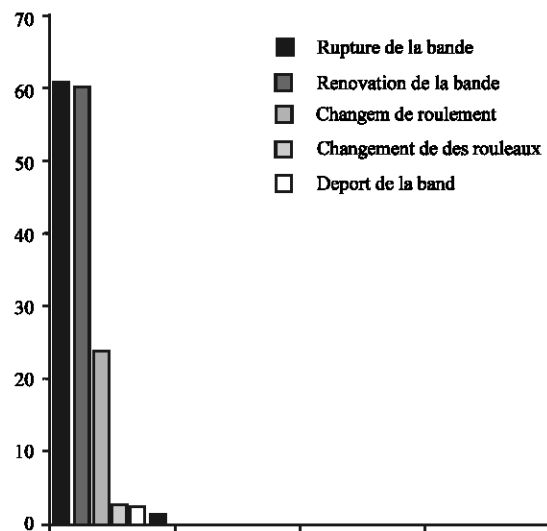
Fig. 1: Analyze failures of a conveyor in a mine

Considering the results of the research carried out on grounds in the various companies, one notes the various breakdowns whose origin is due to the effect of several causes. One of the most frequent breakdowns and which has a harmful effect on the correct operation of the conveyors and consequently on the production of the company is not other than the rupture of the band. It is evaluated at an average failure rate of 63.68%.

It is concluded that this rate is raised the most compared to the other failures detected during the censuses carried out. That does not prevent that one should not neglect the other causes which are rather considerable such as: the electric defect on the level of the engine estimated at (20.13 %), the detachment of against estimated weight (6.43%) offset of the band estimated at (2.18%) and the mechanical breakdown.

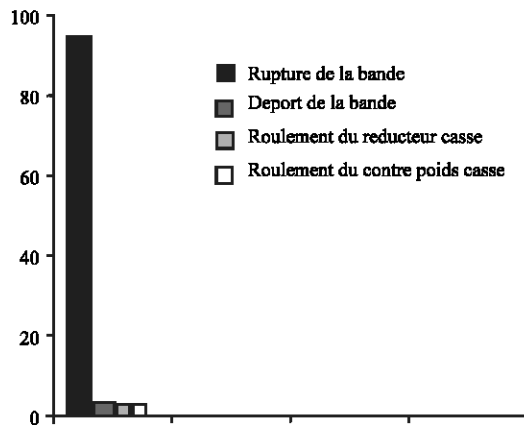
Fig. 2: Analyze failures of a conveyor in a company

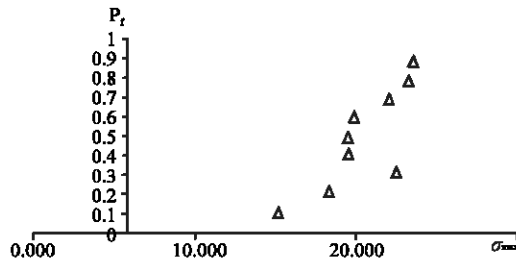
In any obviousness the evolution of the probability of the rupture is proportional to the constraint. The results are represented on Fig. 3. The measurement of the parameter of Weibull (m) is shown on Fig. 4.

Fig. 3: Variation of the probability of rupture in function evolution of the constraint

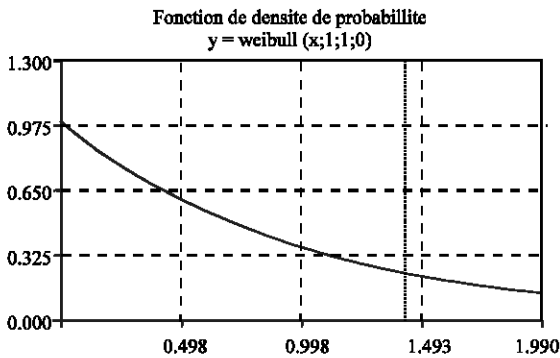
The module of calculated Weibull is about m = 6.854. This order of magnitude falls under the beach of the values of the module of Weibull relating to the composites.

Fig. 4: Weibull's model

With each T sys = 459.3 h, intervening us on the conveyor to keep one Reliability of 75% for that it will be necessary to apply a range of preventive maintenance systematic.
