## A Study on Visual Assessment of Sylhet-Sunamganj Highway Using an Expert System

**Abstract:** The primary function of pavement is to distribute the concentrated loads so that supporting capacity of the sub-grade soil is not exceeded. Due to continuous application of impact loading, pavement surface often subjected to various types of distresses. The study was conducted on a portion (madina market to tucker bazar) of Sylhet-Sunamganj road that acts as a very important link between two adjacent towns. Pavement Condition Ratings (PCR) of the pavement was obtained on the basis of severity and extent of different types of distresses such as alligator cracks, longitudinal cracks, potholes, rutting, raveling, patching, etc. The PCR values of different segments of madina market to tucker bazar were evaluated in this study most of which fall within the category of very poor to poor conditions. Such condition of PCR immediately recommends proper treatment of the pavement for usage convenience.

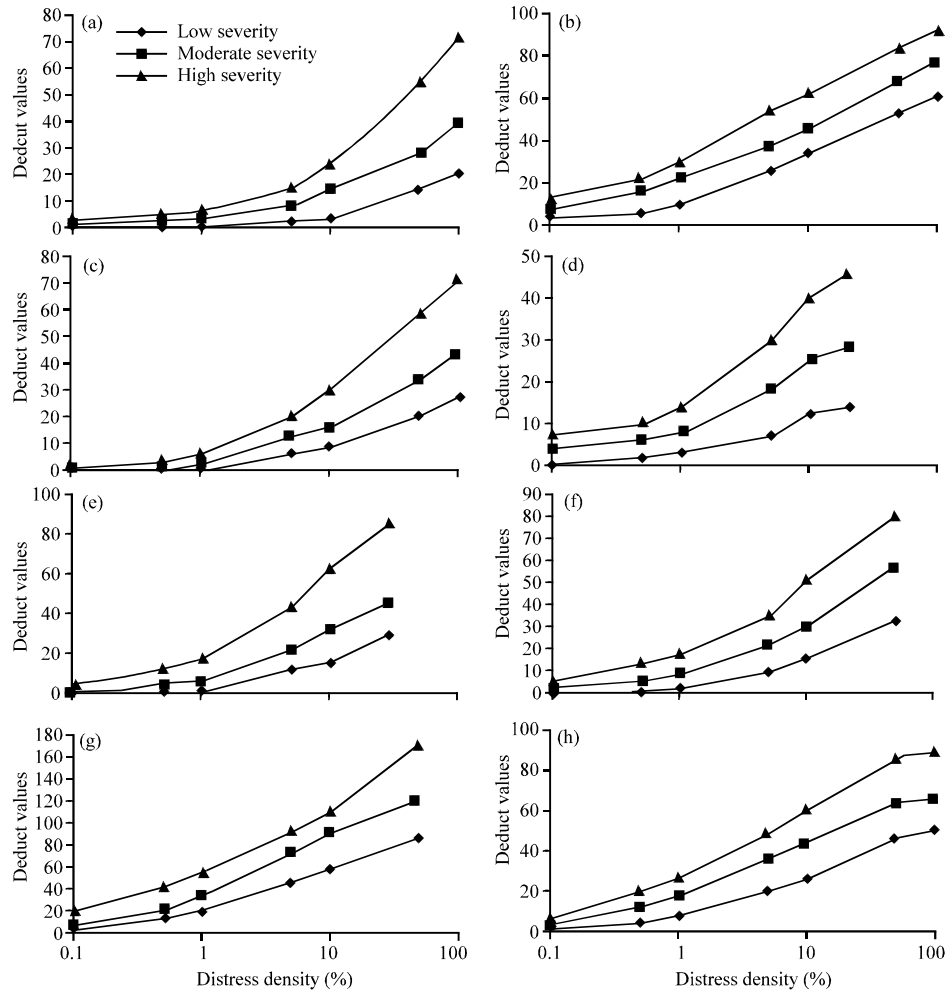
Fig. 2: Deduct values for various distress types, severity and extent: a) Bleeding; b) Alligator cracking; c) Block cracking; d) Edge cracking; e) Longitudinal and transverse cracking; f) Patching; g) Potholes; h) Rutting

**Assessment of extent of distress:** The assessment of extent was obtained using the system of IF-THEN rule. The values for the densities (extent) were recorded. Next, using the calculated densities and the severity (L, M or H), a deduct value for each distress type was determined. The deduct values were determined through the use of deduct value curves for each of the various distress type identified. The curves are the part of the US Army Corporations of Engineers Technical Report TR97/104 (US Army Corporations of Engineers, 1997) (Fig. 2). The mathematical models for each distress type curve were fed to the system. The deduct values for all the distresses were then summed up to produce a deduct total using the mathematical equation given as:

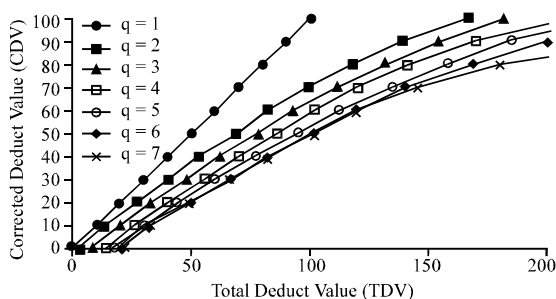
Fig. 3: Relationship between corrected vs. total deduct values

Given the deduct total and a value for the number of deducts >5 points. Figure 3 will be used by the system to determine Corrected Deduct Value (CDV). Finally, the Pavement Condition Rating (PCR) was calculated using the following equation:
