Mechanical Testing of High Performance Vehicle Composite Flywheel for Optimal Performance

Abstract: Flywheel energy storage systems employing light weight-high speed composite flywheel can be evaluated to replace the traditional heavy wheels in vehicles. The composite flywheel can provide extended operating life and significant reduction in weight and volume comparatively. This study describes the testing of a composite vehicle composite flywheel with emphasis on materials allowable test methods, design criteria and analysis techniques. The flywheel is a composite of an aluminium alloy hub, cast iron friction surface and a steel alloy gear rim resulting in compact, lightweight, high energy density structure. The study also describes the heat treatment processes to upgrade metallurgical and mechanical properties; including hardness test, tensile test, vibration analysis and dynamic balancing. The aluminium hub was solution treated and artificially aged, cast iron friction surface was annealed and the steel rim quenched and tempered. The components were assembled using high strength fasteners. A description of the experimental setup and a discussion of spin testing of the wheel up t

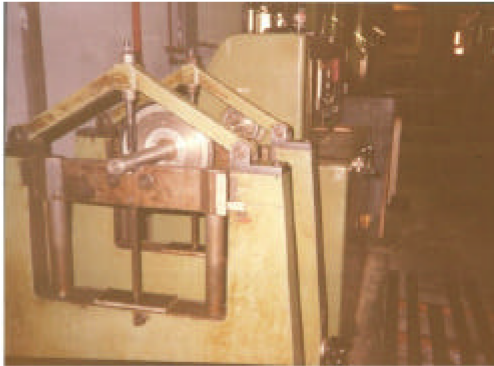
Vibration analysis of flywheel: During the weeks of July 3-21-2006, a composite flywheel was mounted and tested at the Nigerian National Petroleum Corporation (NNPC), Ekpan Test Device. The flywheel was mounted temporarily in the balance machine with the use of a precision mandrel clamped onto the outer diameter of the steel hub at the universal joint, which is supported in bearings (Inboard and Outboard) within the balancer. These two bearings are each mounted on a suspension, which has an inbuilt transducer that measures dynamic force. Plate 1 is a photograph of the flywheel mounted by the mandrel from the balance machine.

Plate 1: The flywheel mounted on balance machine

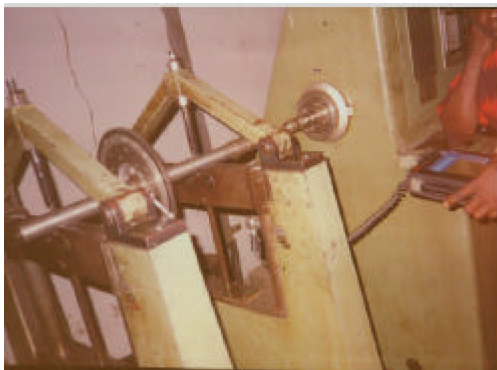
Dynamic balancing was carried out using CSI Ultraspec 8117 balancing kit. Plate 2 is a photograph of the arrangement.

Plate 2: Taking vibration and balance data

Vibration analysis was carried out on the flywheel using a CSI 2120 portable dual channel vibration analyzer, tachometer, speed laser sensor and CSI machinery management software (Vib View Platinum). The diagnostic facts for the test include:

- The measurement orientation is radial.
- There is excessive vibration at 1 × RPM.
- The 1 × RPM is one of the biggest peaks.
